**Kenya's Water Towers Protection and Climate Change Mitigation and Adaptation (WaTER) Programme**

## **Baseline Report: Water Quality in Mt. Elgon and Cherangany Forest Ecosystems (River Nzoia Catchment)**

**Component 4: Science to Inform Design of Community-Level Actions and Policy Decisions**  
**Project Report of March, 2018**

**Kenya Forestry Research Institute  
(KEFRI)**

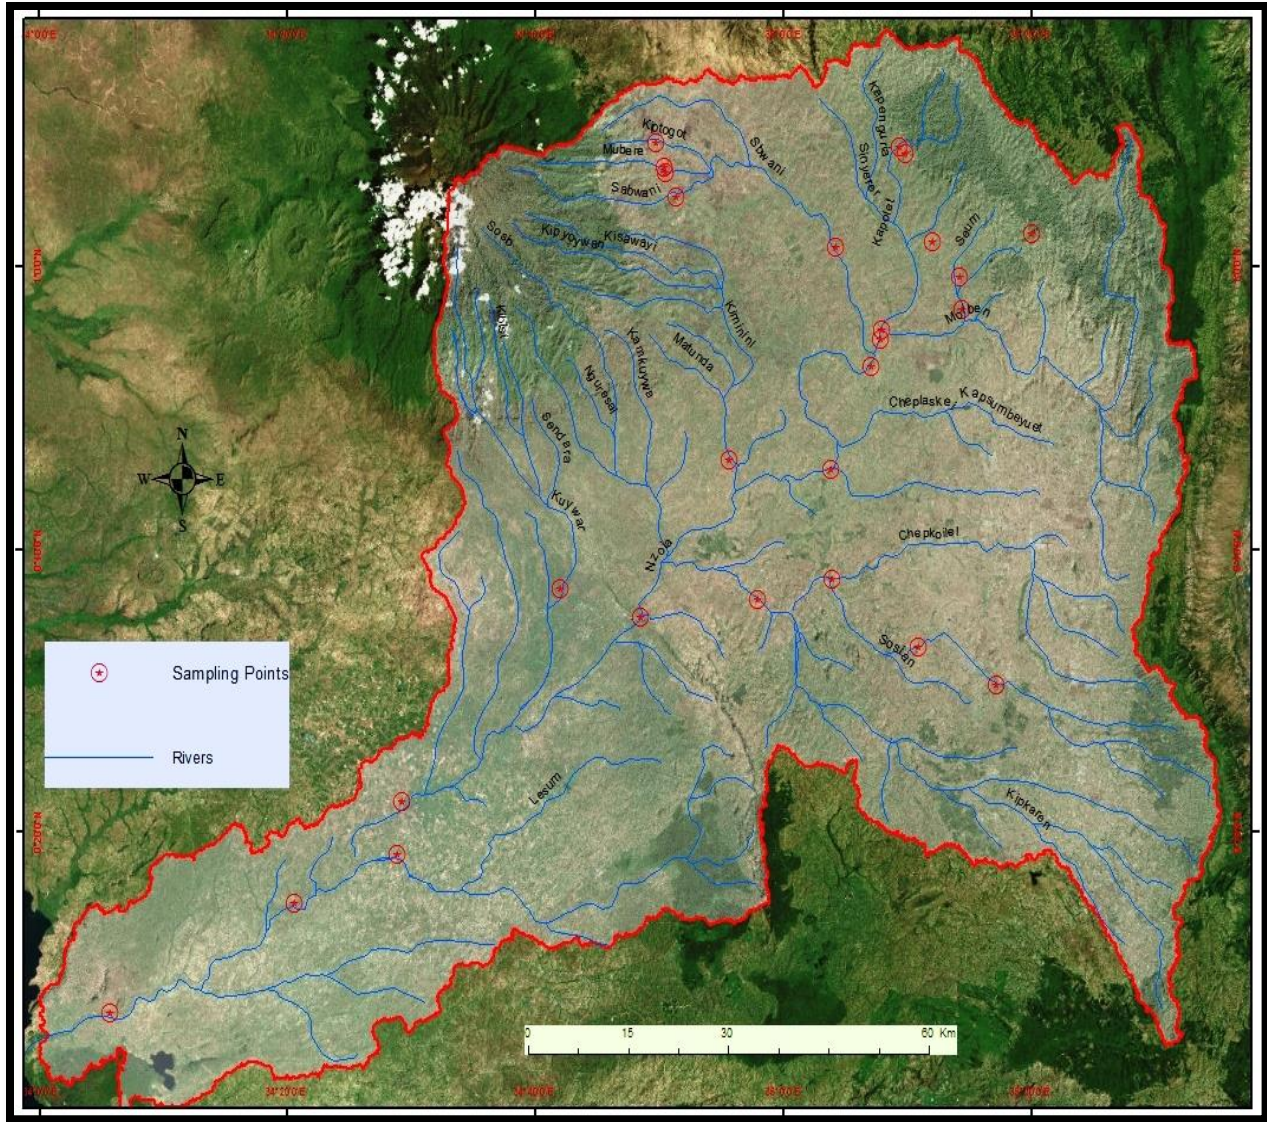
**Figure 2: A map of water and sediment quality monitoring sites in the River Nzoia catchment**

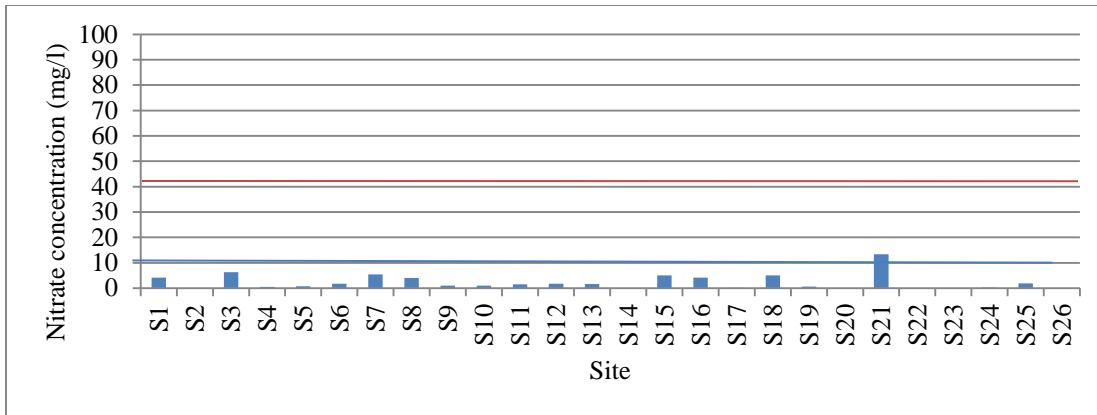
**Figure 4: Nitrate levels in water**

Nitrate and nitrite levels in both water and sediment had similar trends in selected sites notably Sosiani River whereby the high levels in water correlated with the sediment levels. In addition, the farming activities around the sampled areas could also have contributed to the nitrate levels in sediments (Figure 9). The undetected levels of nitrate in sediments in some sites were largely attributed to high solubility of nitrates in water (Figure 4).

The high levels of nitrates and nitrites were attributed to pollution from the nearby town industries and agricultural activities in the region. The high levels of nitrate in the river Nzoia catchment have been associated with water hyacinth and algae blooms in the Lake Victoria adversely affecting fish and other aquatic animals. According to the United States Environmental Protection Agency (USEPA) (1999), consumption of water by humans containing high levels of nitrate in excess of 10 mg/L could lead to adverse health effects such as methemoglobinemia (“blue baby” syndrome).

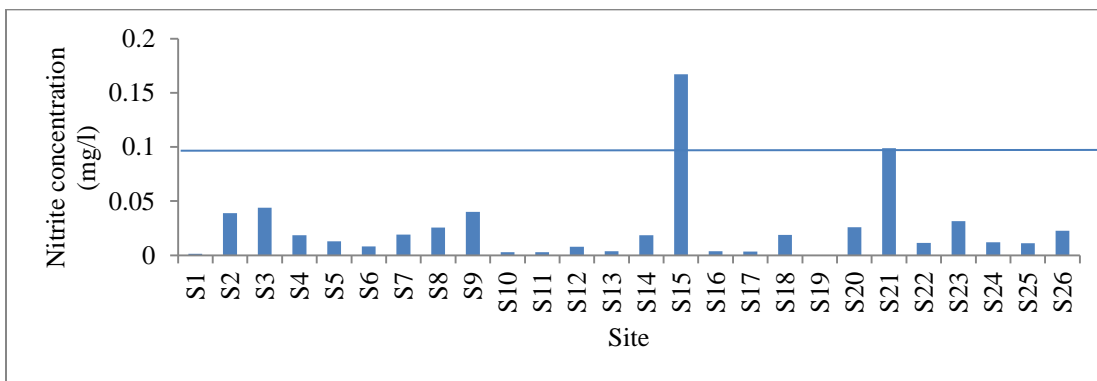
**Figure 5: Nitrite levels in river water**

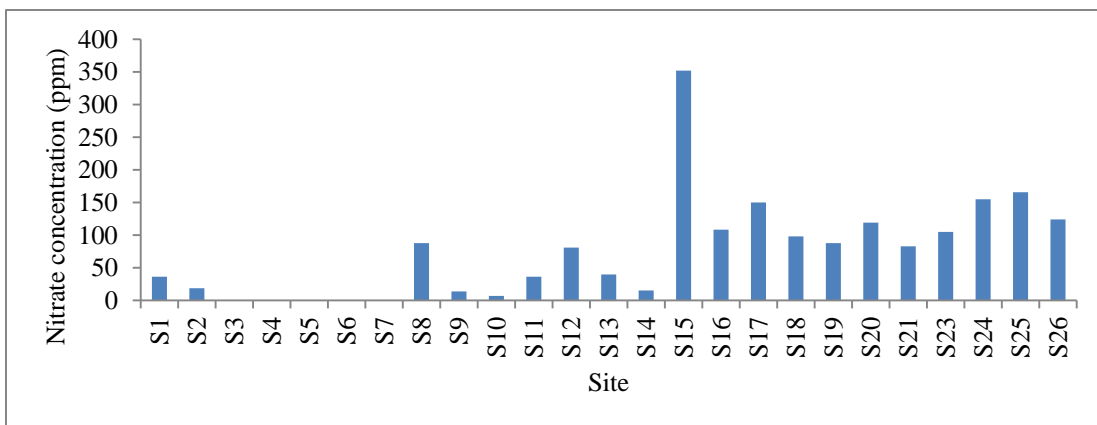
**Figure 6: Nitrates in river sediments**

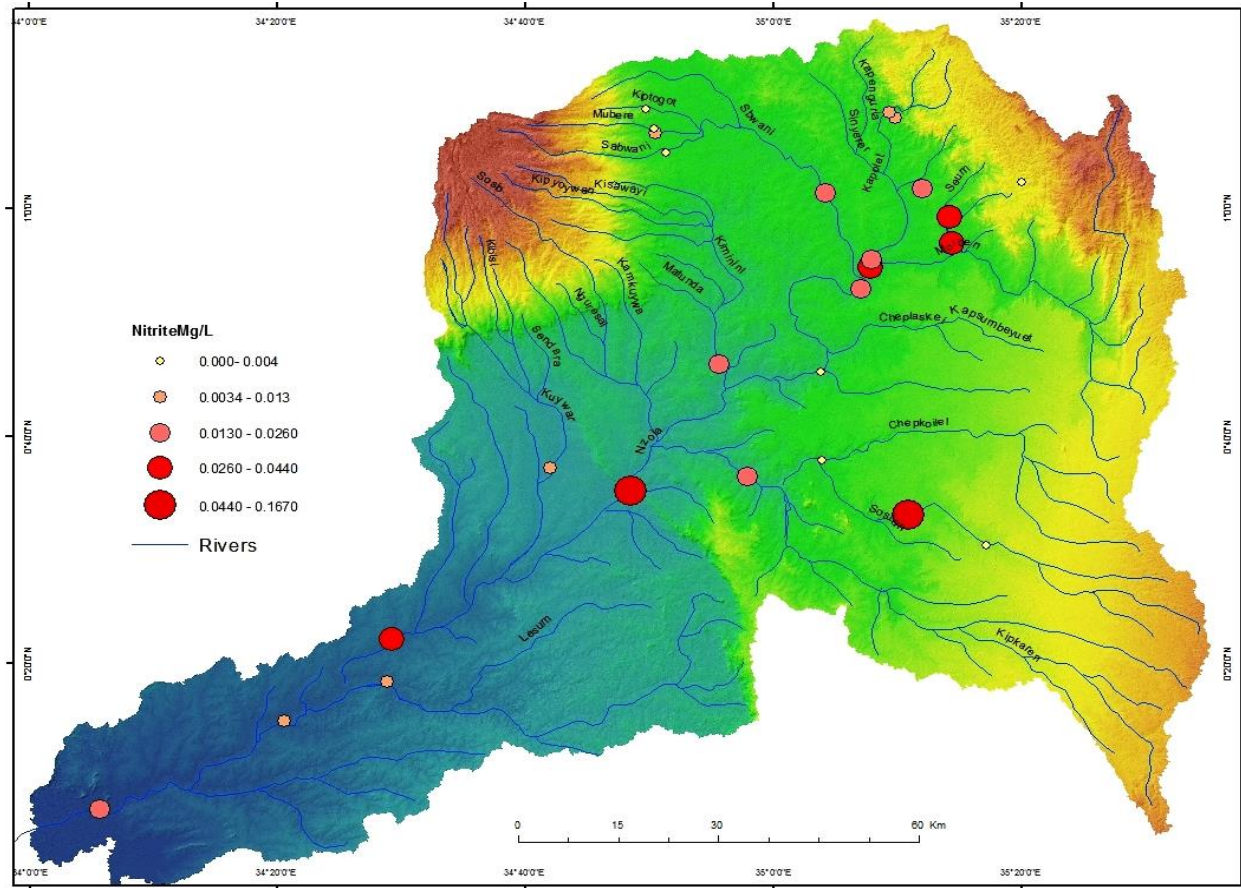
**Figure 8: Pollution map for Nitrite levels in water**

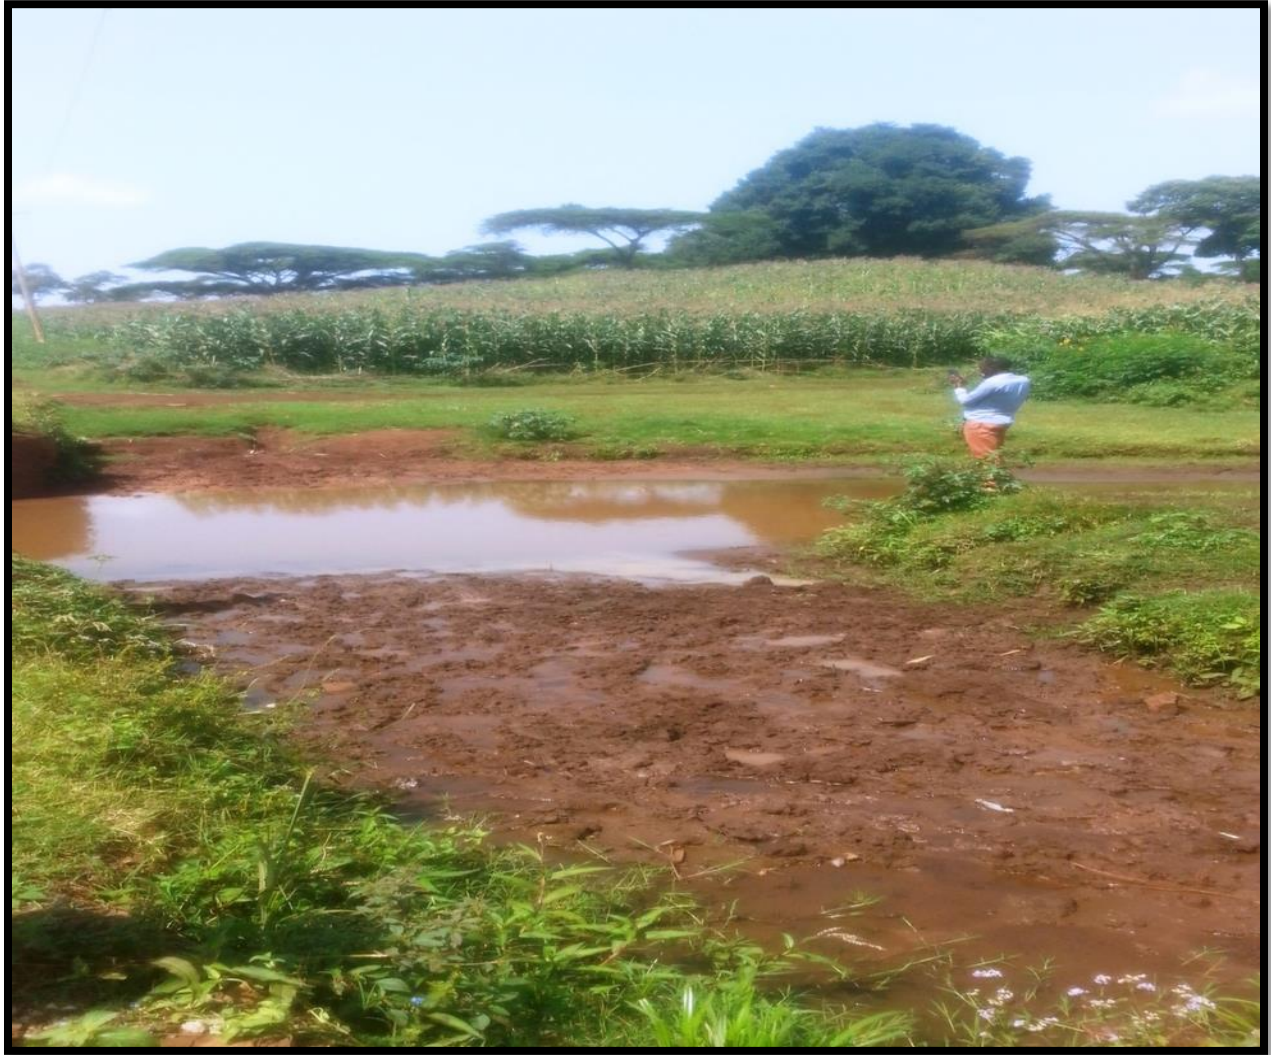
**Figure 9: River Kaibey/Koitobos in Mt. Elgon Forest Ecosystem polluted due to intensive agricultural activities in the area**

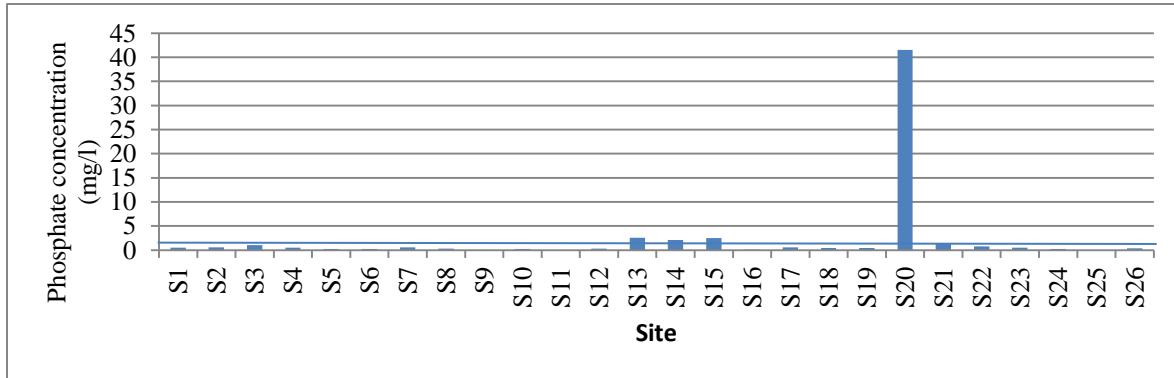
**Figure 10: Phosphates levels in water**

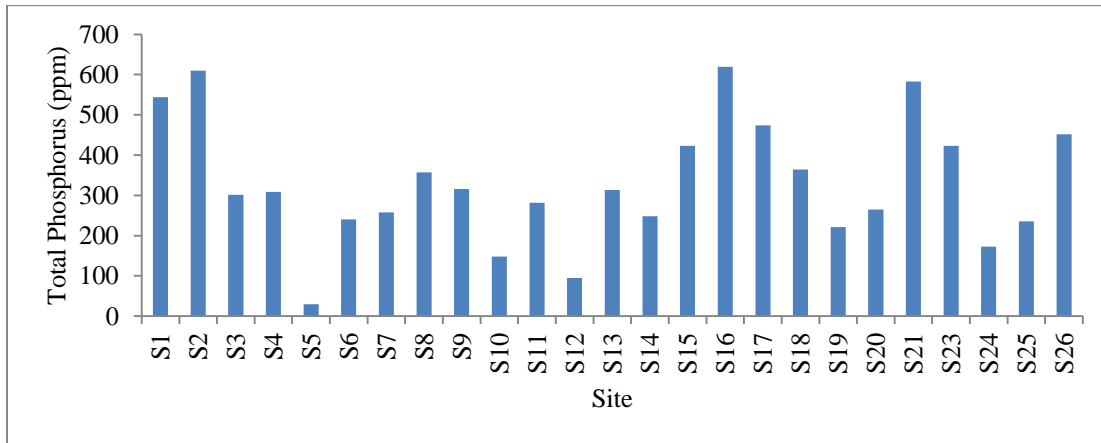
**Figure 11: Total phosphorous in sediments**

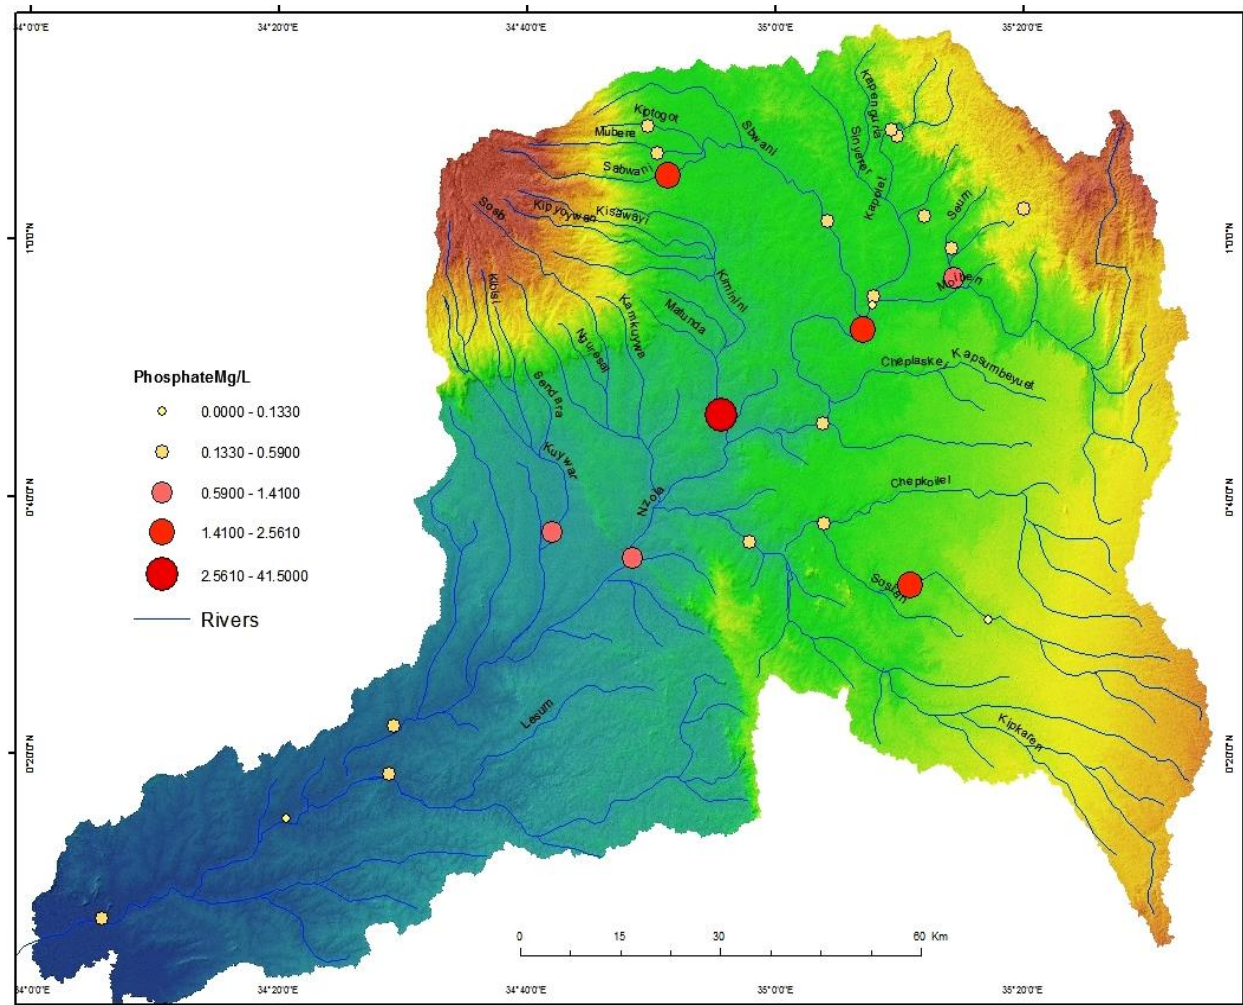
**Figure 12: Pollution map for Phosphate levels in water**

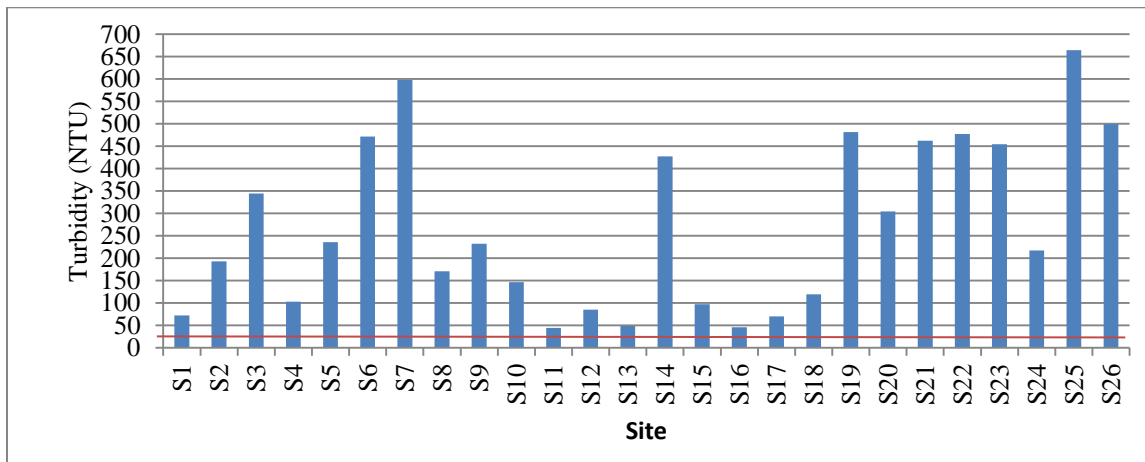
**Figure 13: Turbidity levels of water**

Turbidity indicates the clarity (murkiness) of water and provides an insight on the inorganic particles present as total suspended solids. Turbidity levels of the sampled rivers were high (45-700 NTUs) and beyond acceptable limits set for drinking water in the environment in Kenya (KEBS, 2014) i.e. 25 NTUs and therefore requires timely interventions. These high levels were attributed to seasonal weather variations and land use activities at the time of sampling whereby it was in a rainy season with high rates of soil being eroded into rivers through surface runoff (Figure 15). Furthermore, high turbidity was also synonymous with big rivers perhaps due to high sediment load as a result of high discharge volumes as shown both in the upper and lower catchment areas of river Nzoia near the mouth of Lake Victoria (Figure 13; Figure 14). For instance, River Nzoia at Kapolet Bridge (471 NTUs), River Koitobos at Koitobos Bridge (597 NTUs), and the larger River Nzoia at Moi'sbridge bridge (427 NTUs), Sigomre and Ruambwa bridge (664 NTUs), sites are big rivers which were very turbid (Figure 13). Low clarity levels in water reduce sunlight absorption causing high temperatures which in turn lower oxygen levels. This is detrimental to aquatic life as photosynthesis is also affected due to reduced light penetration.

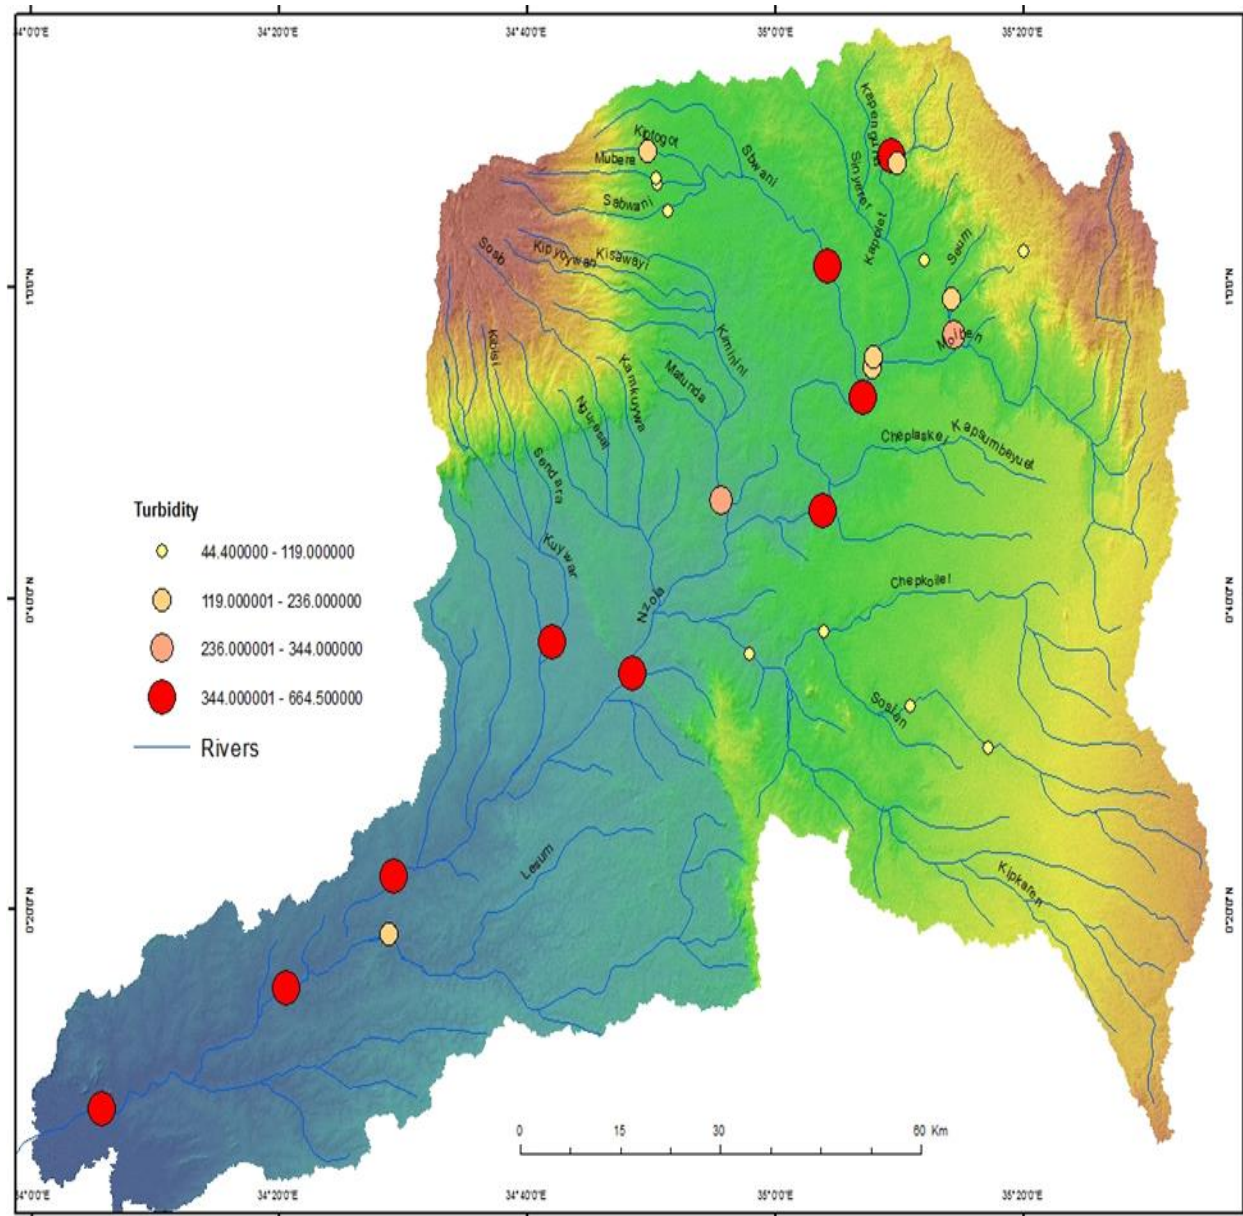
**Figure 14: Pollution map for Turbidity levels in water**

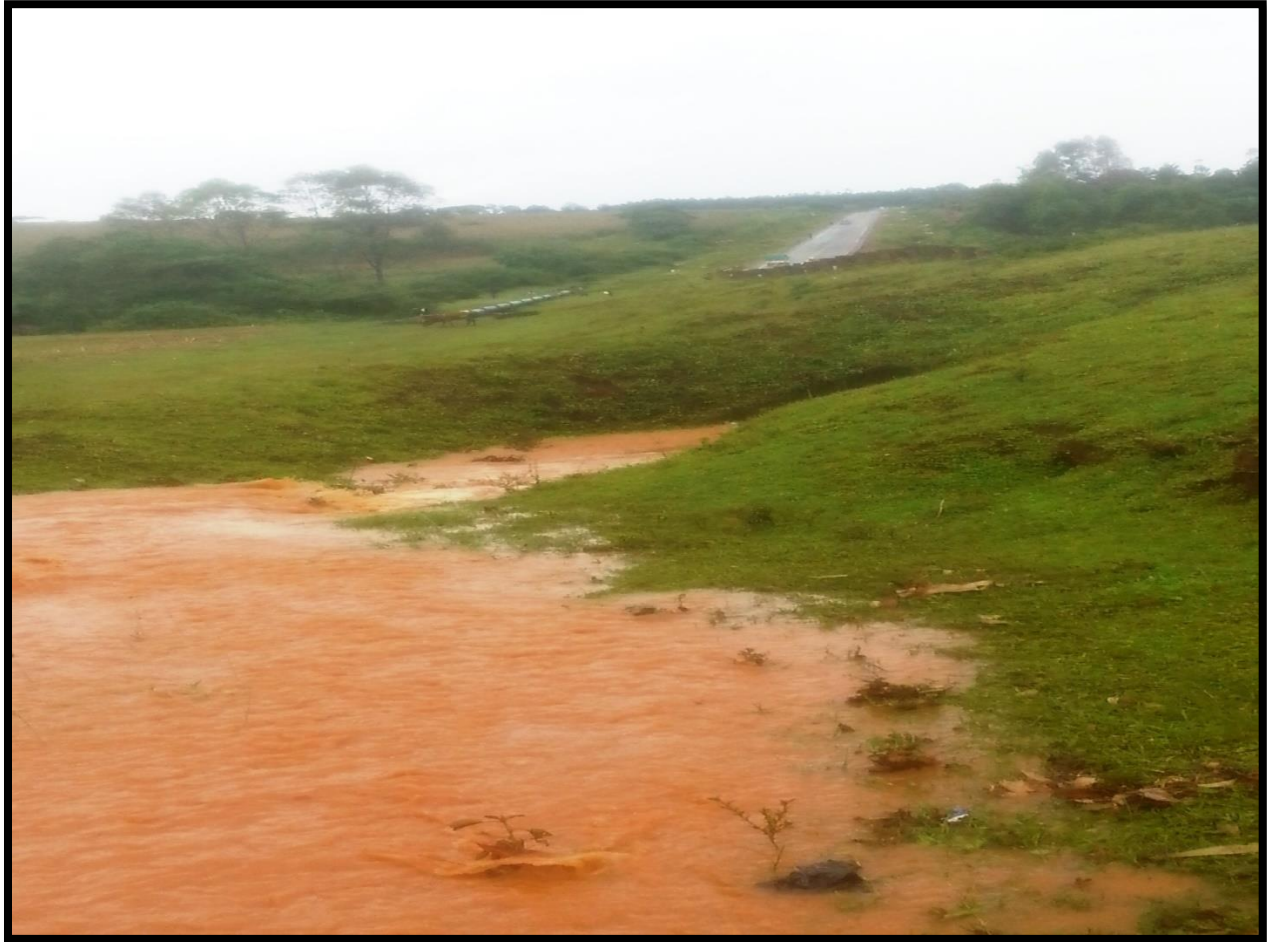
**Figure 15: Highly turbid surface runoff waters caused by soil erosion from farms around Koitobos, Cherangany Forest ecosystem**

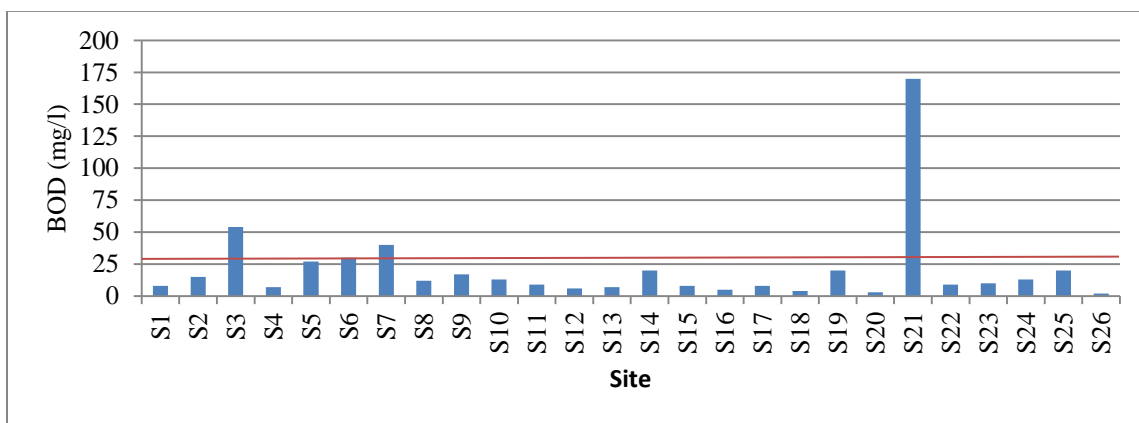
**Figure 16: Biochemical Oxygen Demand (BOD) of water**

In this study, both BOD and COD levels had similar trends in the sampled sites with nearly all the sampled sites/ivers being within the acceptable limits in the environment. River Chepkaitet at Chepkaitet bridge, river Koitobos at Koitobos bridge and the larger river Nzoia near Webuye town had levels above the threshold value of 30 mg/l (BOD) and 50 mg/l (COD) permitted in the environment (NEMA, 2006) as shown in the figures 20, 21, 22 and 23. High BOD/COD levels in river Nzoia near Webuye town was attributed to industrial effluents from industries around the town and sewage treatment plants. For Koitobos and Chepkaitet sites, organic materials from highly fertilized farms and pesticides especially flowers and cereal maize farms in the area were the most likely causes of the high BOD/COD levels (Figures 16, 17, 18 and 19). In river water quality, BOD is mostly associated with wastewater from sewage systems while COD associated with industrial effluents. To reduce or manage high BOD/COD values, proper design of waste water and sewage treatment plants should be done especially aeration. Therefore, the waste water effluent and sewage discharges should be monitored in the affected areas as a way of reducing point source pollution in the rivers.

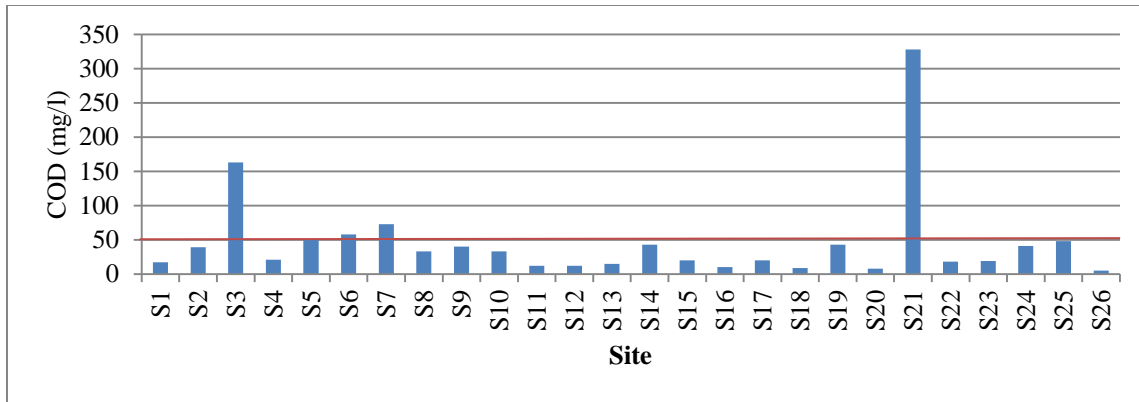
Figure 17: Chemical Oxygen Demand (COD)

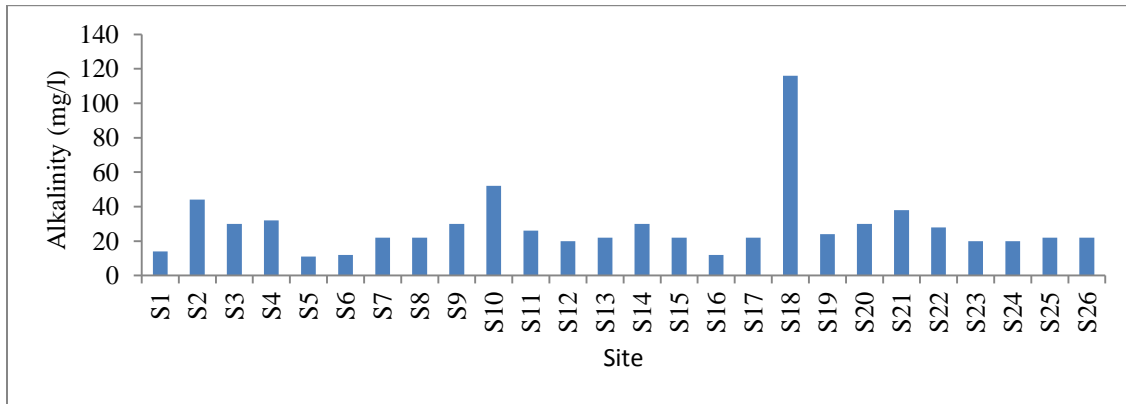
Figure 20: Alkalinity levels in water

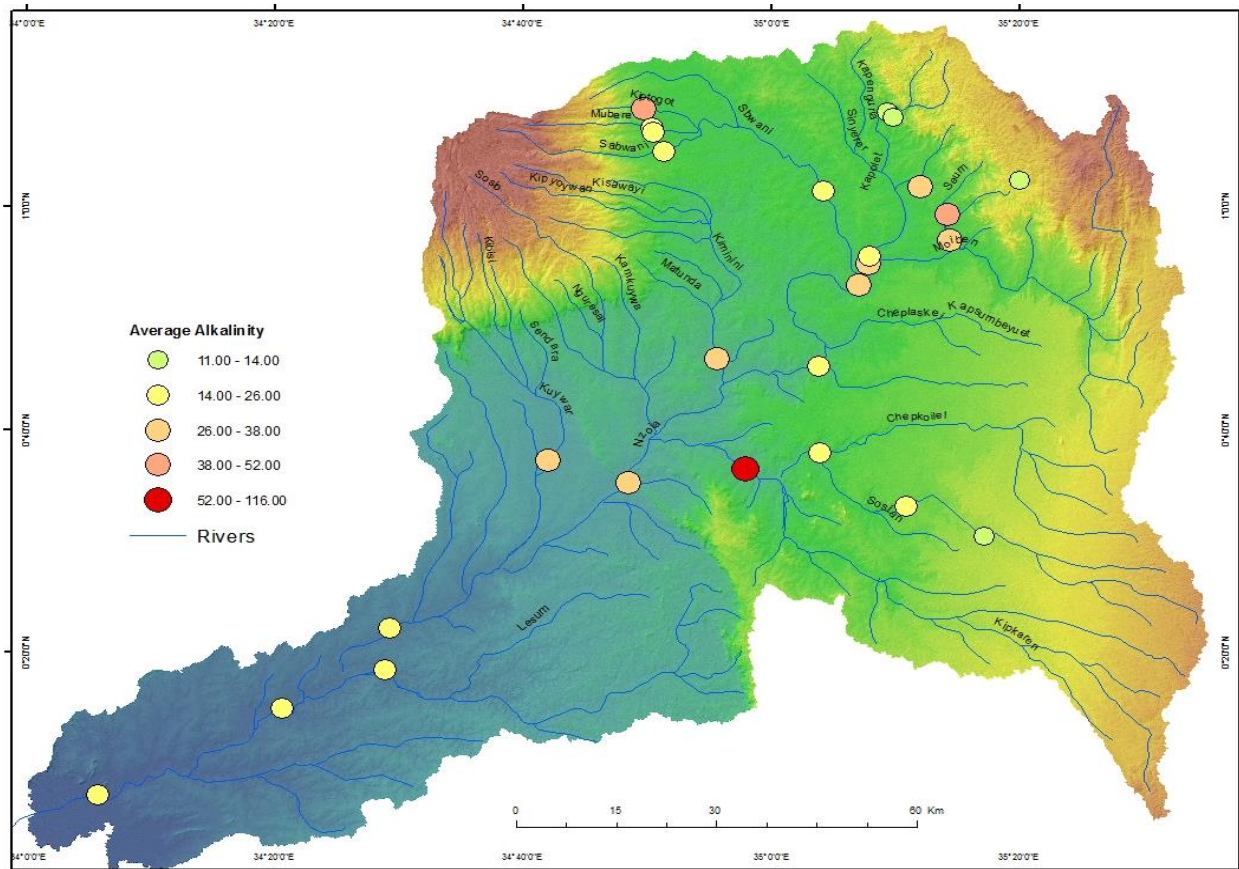
Figure 21: Pollution map for Alkalinity levels in water

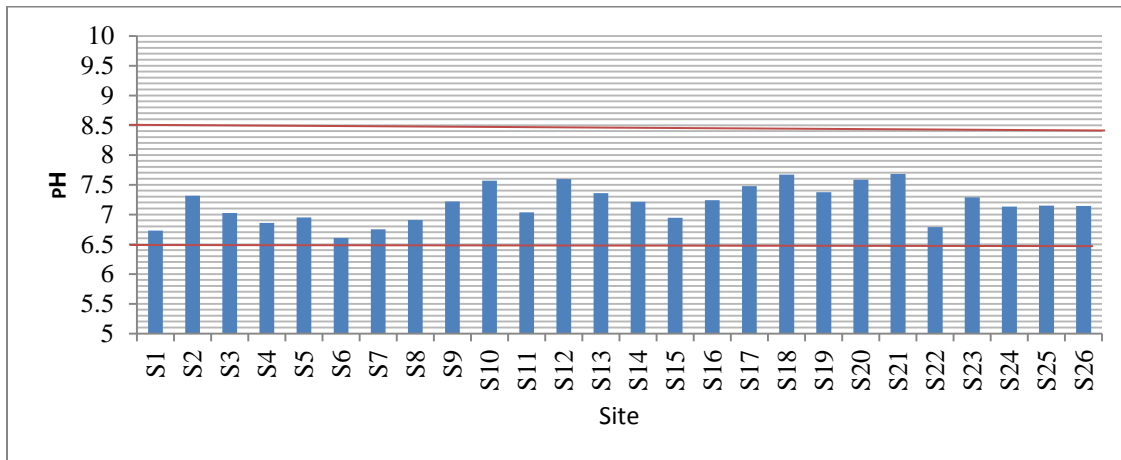
**Figure 22: The pH levels in water**

The pH values of the sampled rivers were all within acceptable limits (NEMA, 2006; KEBS, 2014). The same trend was observed for sediments except for River Nzoia at Kapolet Bridge which recorded a low pH of 5.75 (Figure 22, Figure 23). The low pH could be attributed to anthropogenic activities mostly pollution from phosphates and nitrate fertilizers as well as animal watering points in the sub-catchment. Most aquatic organisms prefer water with pH range of between 6.5 and 8.4. Water with a pH of less than 4.8 or greater than 9.2 can be harmful to aquatic life.

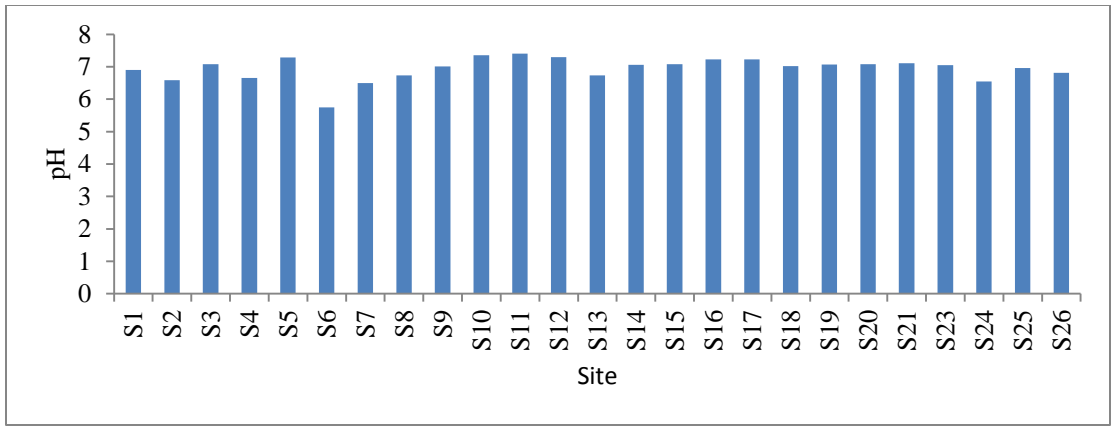
**Figure 23: The pH levels for sediments**

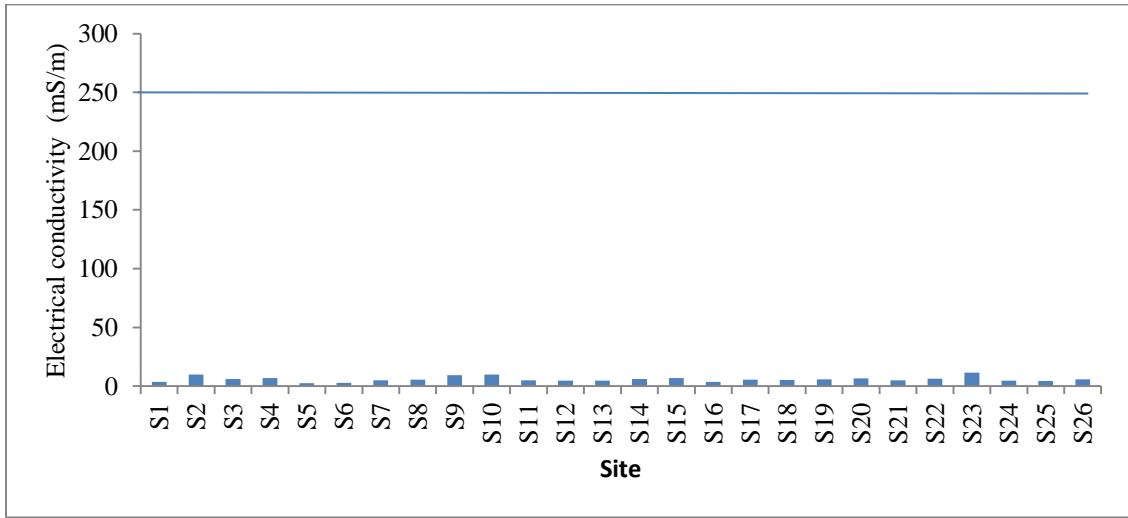
**Figure 24: Electrical conductivity of water**

The electrical conductivity of the river waters were within the acceptable limits (2.5 -11.5 mS/m) against maximum acceptable limit of 250 mS/m (KEBS, 2014) (Figure 24, Figure 25). This implied that there was a low pollution of ionic salts in the rivers from the catchment. For sediments, there was a correlation between the electrical conductivity and metal cations concentration for copper, zinc and magnesium (Figures 34- Figure 39).

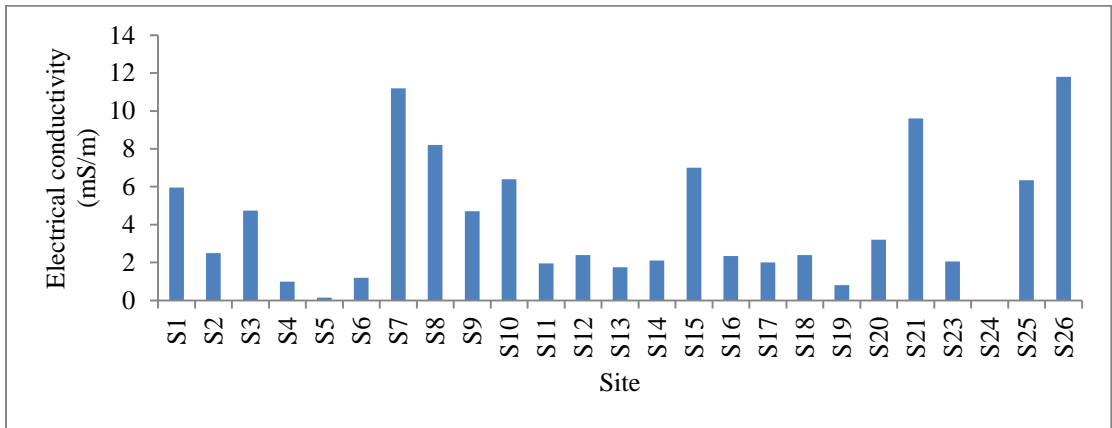
**Figure 25: Electrical conductivity for sediments**

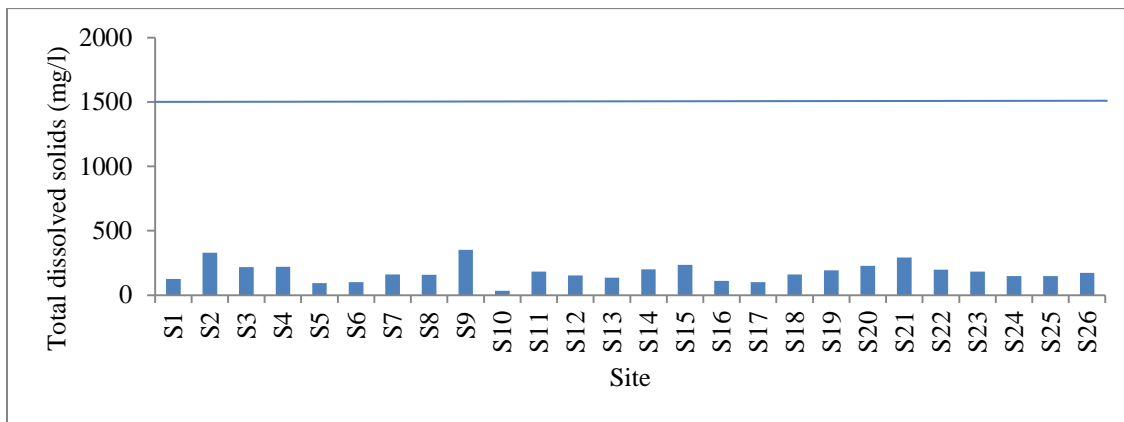
**Figure 26: Total Dissolved solids in water**

The total dissolved solid is a measure of the total amount of natural and anthropogenic all the materials dissolved in water. In Kenya, the total dissolved solids (TDS) concentrations in drinking water should not exceed 1200 mg/L (KEBS, 2014) while water quality standards for domestic water sources should not exceed 1500 mg/L (NEMA, 2006). All the recorded concentrations of total dissolved solids (33 – 352 mg/L) were below the maximum allowed limits implying that the river water do not have high concentration of dissolved solids (Figure 26 and 27).

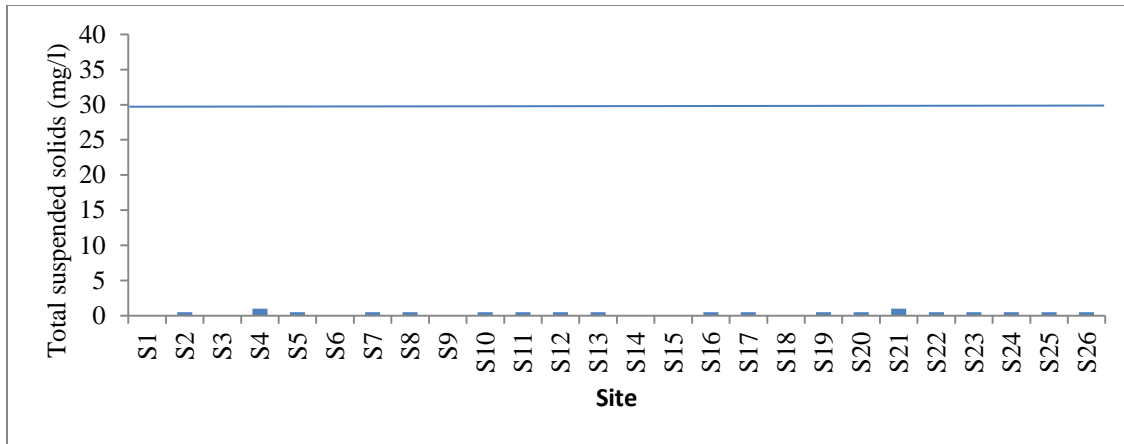
**Figure 28: Total Suspended Solids in water**

The total suspended solids measures floating particles in water. TSS has an inverse relationship with water transparency. In this study, the volume of the suspended solids in water in all the sub-catchments were within the NEMA water quality regulations acceptable limits of 30 mg/l for domestic and commercial water in Kenya (NEMA, 2006) in Figures 28 and 29. The low levels of TSS in water were attributed to the sampling period whereby, it was done during the rainy season and river discharge rates were high hence the suspended solids were washed away downstream. However, for drinking water, the TSS levels should not be detected as per KEBS portable water standards (KEBS, 2014).

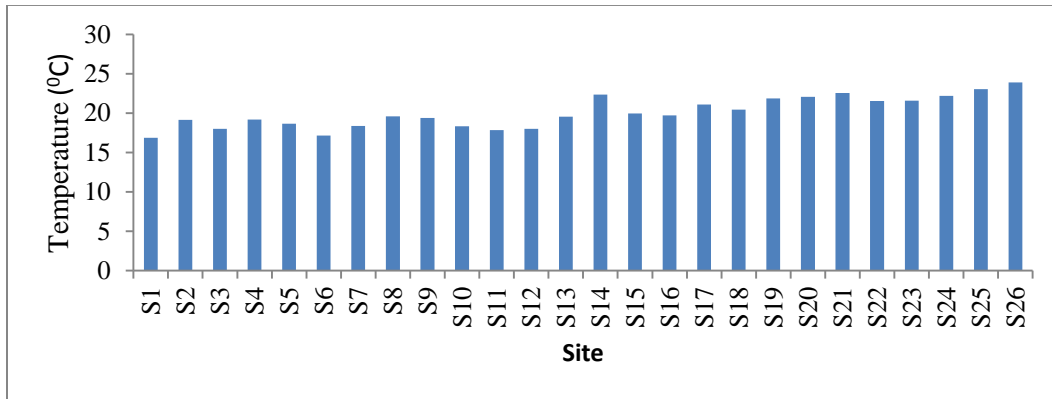
Figure 30: Temperatures of water

Temperatures ranged from 16°C along River Chepkaitit in Kapcherop (2353m absl) to 22.9°C (1180m absl) on River Nzoia at Rwambwa bridge (Figure 30). These water temperatures variations were majorly attributed to altitude and prevailing weather conditions. In addition, other factors known to influence water temperatures include; shading and ground water influx.

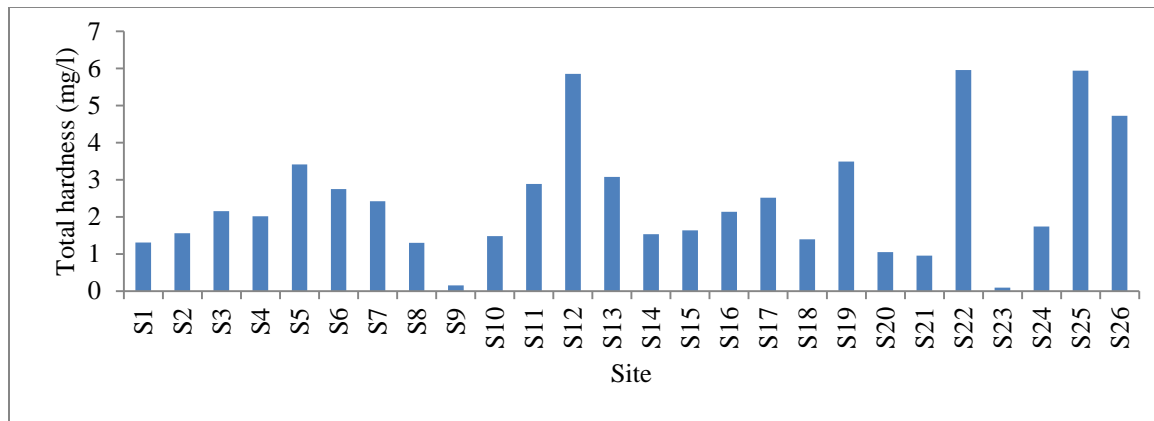
**Figure 31: Total hardness in water**

The total hardness concentrations of the sampled rivers ranged from 0.1 mg/L to 5.96 mg/L, implying that the river waters are soft hence suitable for domestic, agricultural and industrial use (Figure 31). The hardness levels were below the acceptable limits in Kenya set by KEBS of 600 mg/L (KEBS, 2014). Total water hardness is a measure of dissolved minerals mostly calcium and magnesium in water and is expressed as milligrams per liter (mg/L) of calcium carbonate ( $\text{CaCO}_3$ ). Water containing calcium carbonate at concentrations below 60 mg/L is generally considered as soft; 60–120 mg/L, moderately hard; 120–180 mg/L, hard; and more than 180 mg/L, very hard (USGS, 2016).

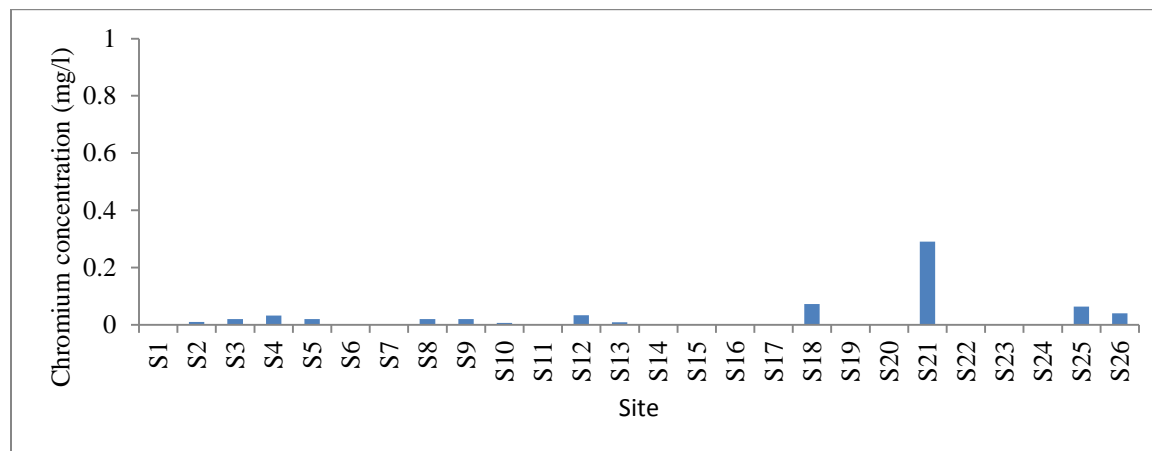
**Figure 32: Chromium concentrations in water**

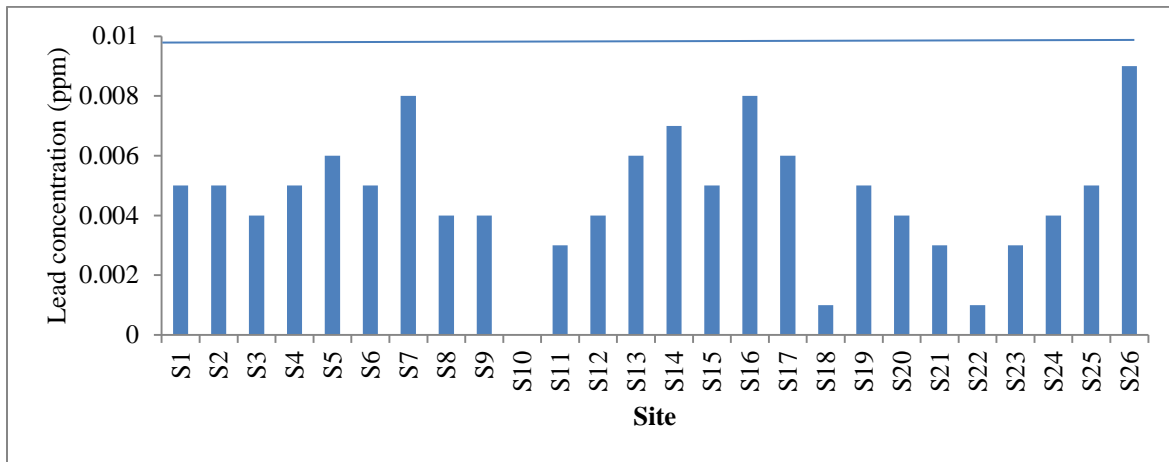
**Figure 33: Lead concentrations in water**

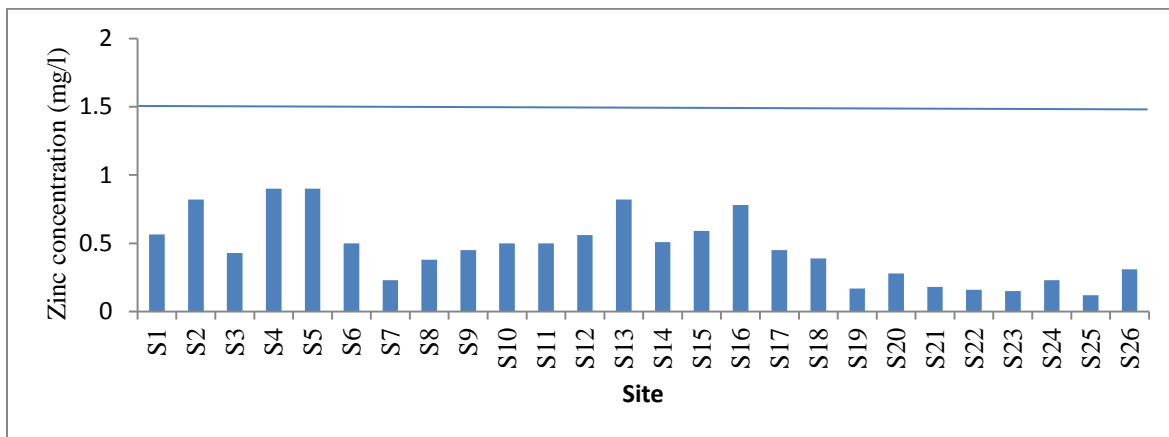
**Figure 34: Zinc concentration in water**

Zinc sources in the environment are mostly from rock minerals and fertilization in agricultural activities. In this study, zinc was recorded from all the rivers sampled (0.12 – 0.9 mg/L) with its values being within the acceptable limits of 1.5 mg/L (NEMA, 2006) as shown in figure 34 and 35. Exposure of zinc to plants may lead to bio-accumulation thus posing health risks along the food chain.

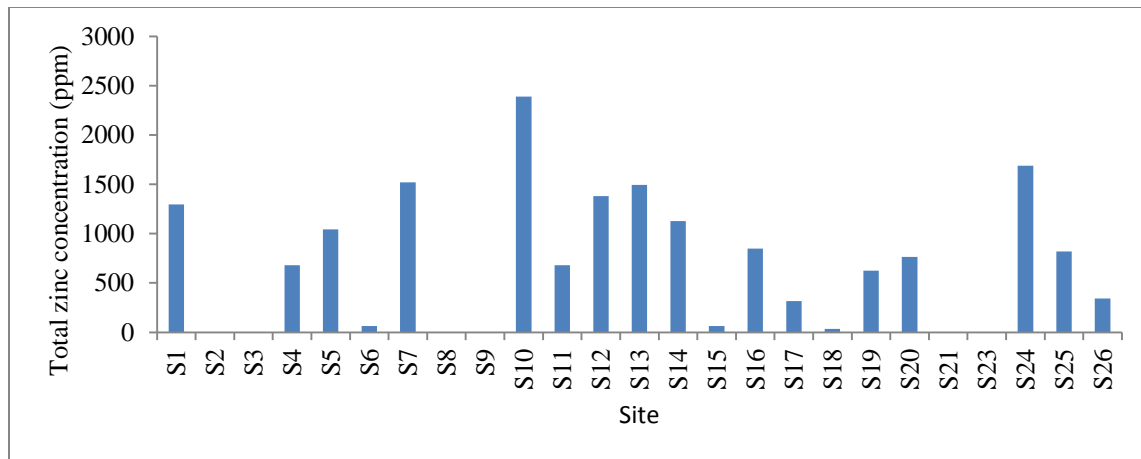
**Figure 35: Total zinc concentration in sediments**

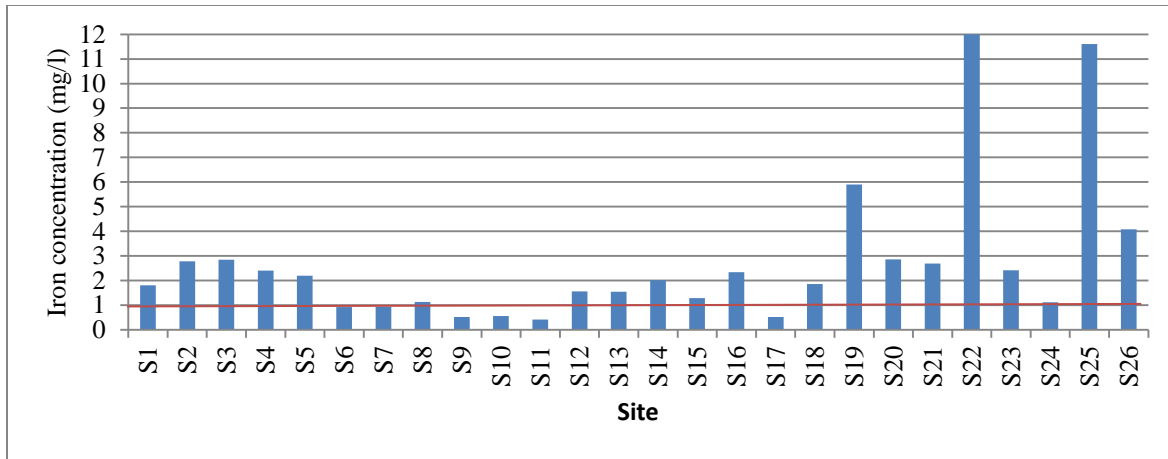
**Figure 36: Iron concentration in water**

In this study, majority of the rivers sampled had iron levels exceeding the allowable limits of 0.3mg/l (KEBS, 2014). River Kuywa water treatment site near Bungoma town (12mg/l) and River Nzoia at Sigomre bridge (11.6 mg/l) recorded the highest iron levels, followed by River Nzoia at Brigadier bridge in Soysambu (5.9 mg/l). The high levels of iron were largely attributed to soil erosion carrying iron minerals to river waters. Intervention measures should include control of soil erosion to reduce the amounts swept in the rivers. For drinking water; filtration, ozonation, chlorination and use of water softeners should be taken in consideration to reduce potential health risks associated with consumption of such water.

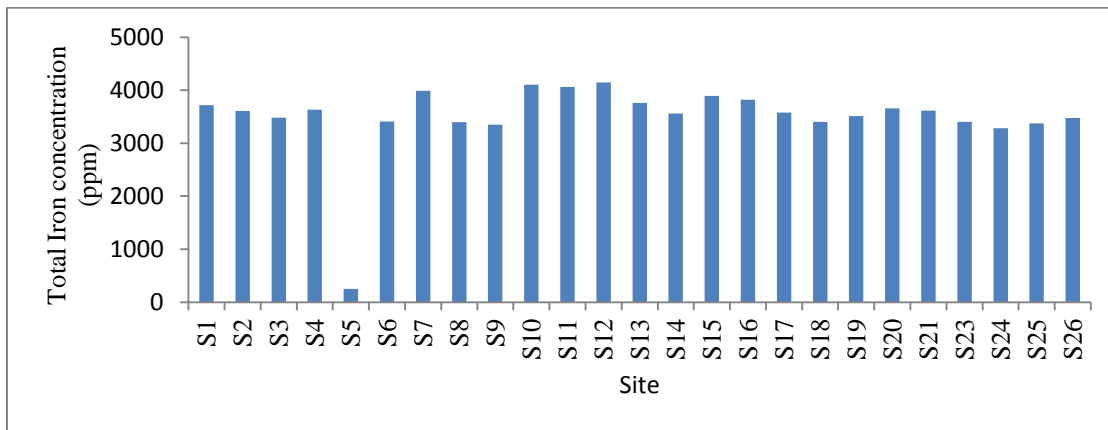
**Figure 37: Total iron concentration in sediments**

For sediments, all the sampled rivers had iron content ranging between 3000-4000 ppm except at the main source of river Nzoia (Kapolet North water treatment site) which had very little sediment mainly white sands. This was consistent with the iron content in water.
