**Kenya's Water Towers Protection and Climate Change Mitigation and Adaptation (WaTER) Programme**

## **Baseline Report: Water Quality in Mt. Elgon and Cherangany Forest Ecosystems (River Nzoia Catchment)**

**Component 4: Science to Inform Design of Community-Level Actions and Policy Decisions**  
**Project Report of March, 2018**

**Kenya Forestry Research Institute  
(KEFRI)**

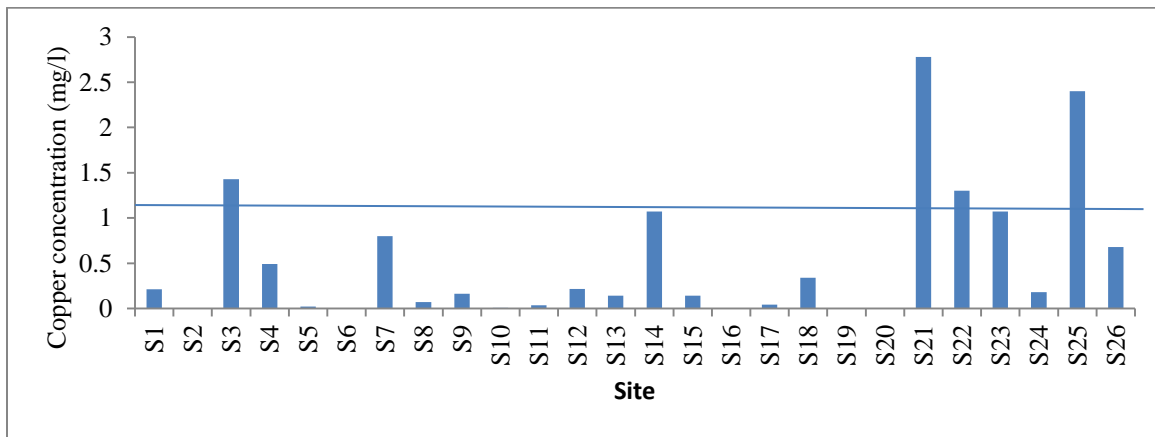
**Figure 38: Copper levels in water**

The 26 sampled sites recorded high concentrations of copper in water against the acceptable limit of 1.0mg/L (KEBS, 2014), with the highest concentrations of 2.78mg/L and 2.4mg/L recorded at River Nzoia at Webuye Bridge and River Nzoia at Sigomre Bridge respectively.

The high levels of copper were attributed to high volume of water at the sites and therefore increased carrying capacities mainly erosion. In addition, point-source pollution from industries near Webuye town discharged into the river and farming activities in the surrounding areas in the surrounding areas are other possible sources. Copper is an essential trace nutrient required in small amounts by humans, plants and animals and therefore mitigating measures are necessary to reduce the high concentrations in the affected areas.

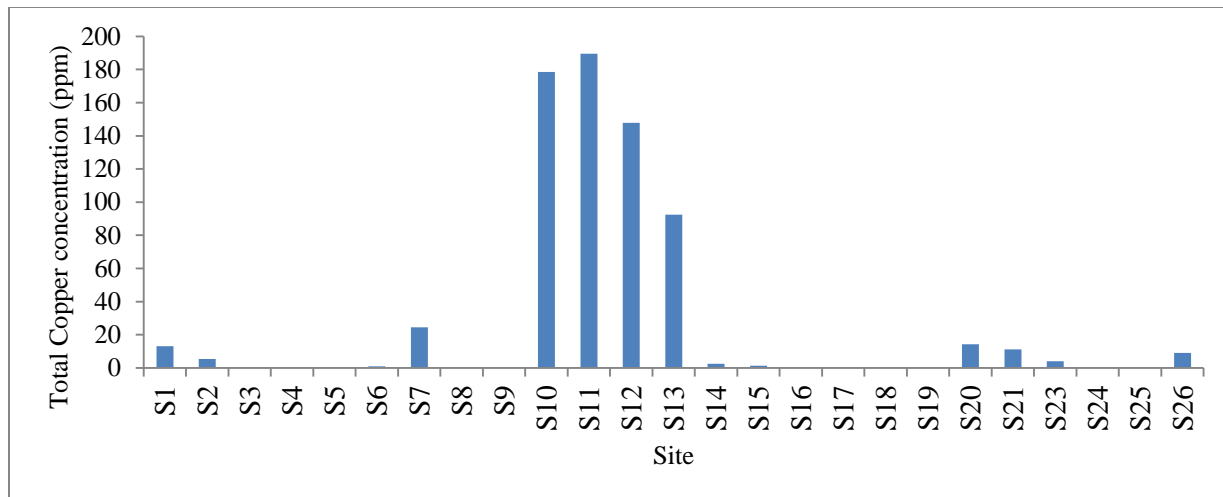
**Figure 39: Total copper levels in sediments**

For sediments, Rivers Kiptogot, Mubere, Kaibey / Koitobos and Sabwani recorded high concentrations of copper i.e. 178.52 ppm, 189.59 ppm, 147.84 ppm and 92.47 ppm respectively. This could be attributed to non-point pollution especially from highly intensified agricultural activities in this region majorly large scale flower and maize production. Copper is moderately soluble in water and binds easily to soil particles and organic matter. The levels of copper in sediments can provide an indication of the level of pollution of the river as the sediments act as permanent or temporary traps for materials present in the river. The effects of copper on aquatic life include fraying of fish gills and reduced olfaction function in fish.

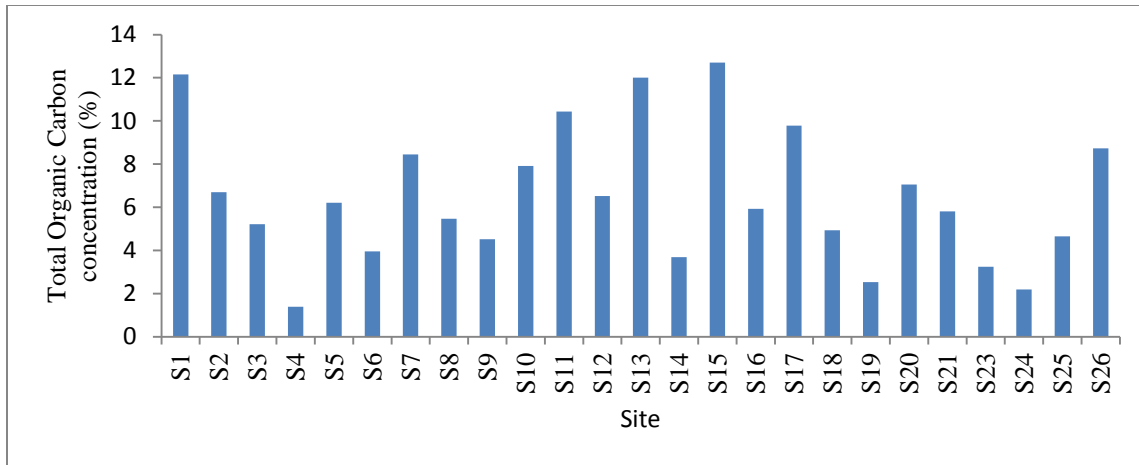
**Figure 40: Total Organic Carbon (TOC) in sediments**

In this study, TOC was measured in sediments and River Chepkaitit at Chepkaitit bridge, Sosian at Kamagut bridge, Mubere (Mubere bridge), and Sabwani (Endebess bridge) recorded the highest TOC levels. The high levels of TOC in sediments in these sites might have been contributed by mostly agricultural activities. The other reasons could be due to runoff from the surrounding farmlands hence bringing along excess pesticides and chemicals from inorganic fertilizers.

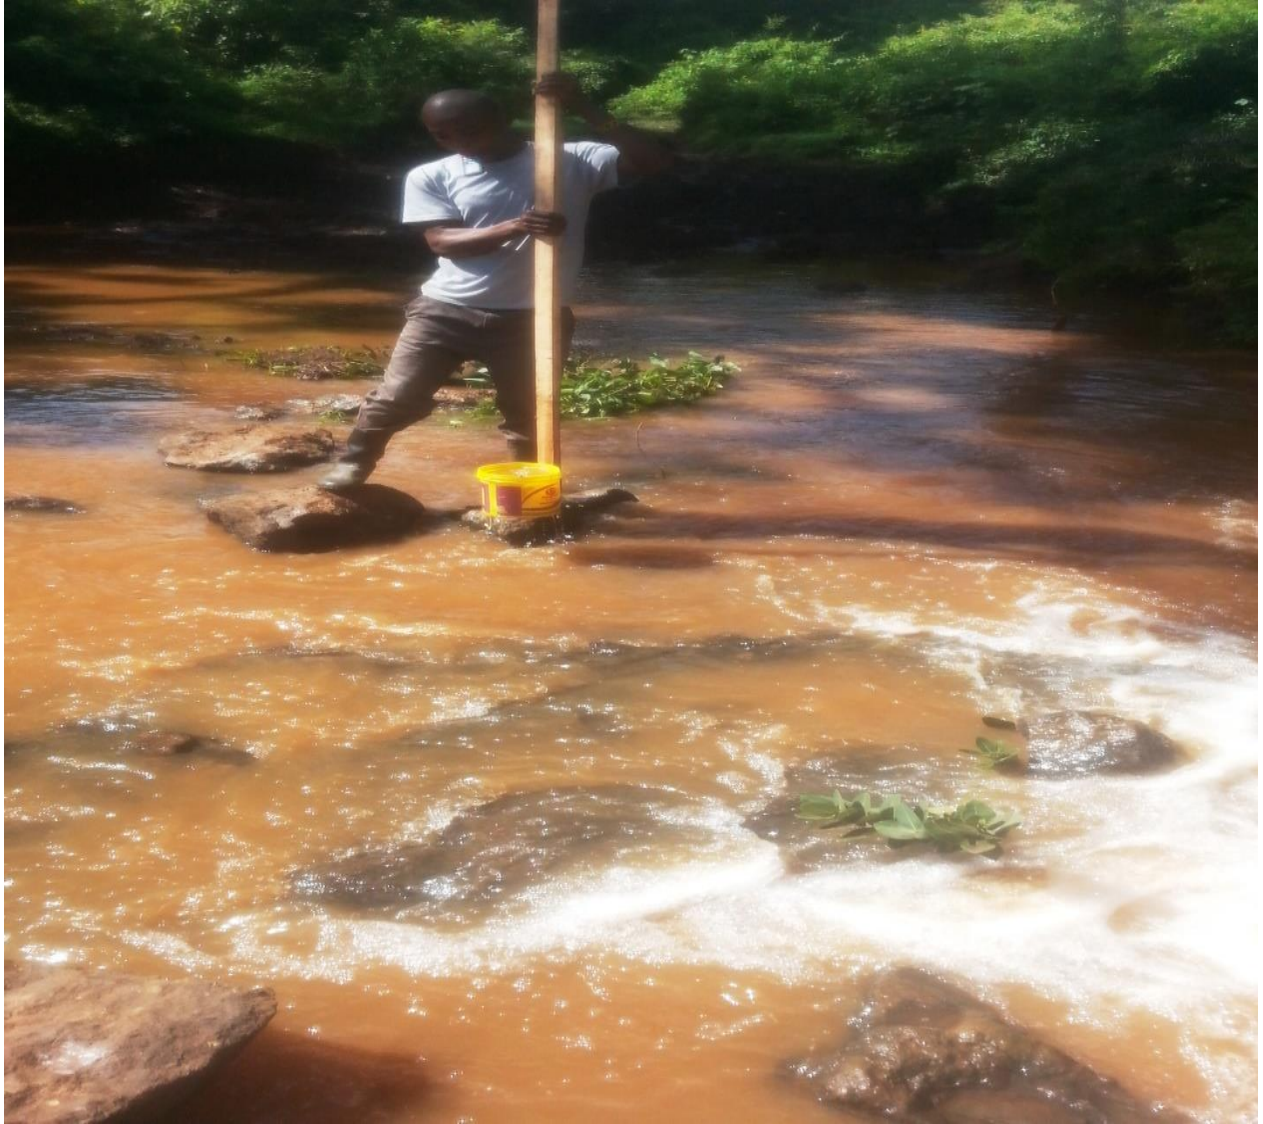
**Appendix 3: Water sampling in River Kiptogot near Chepchoina centre, Mt. Elgon Ecosystem (very turbid waters)**

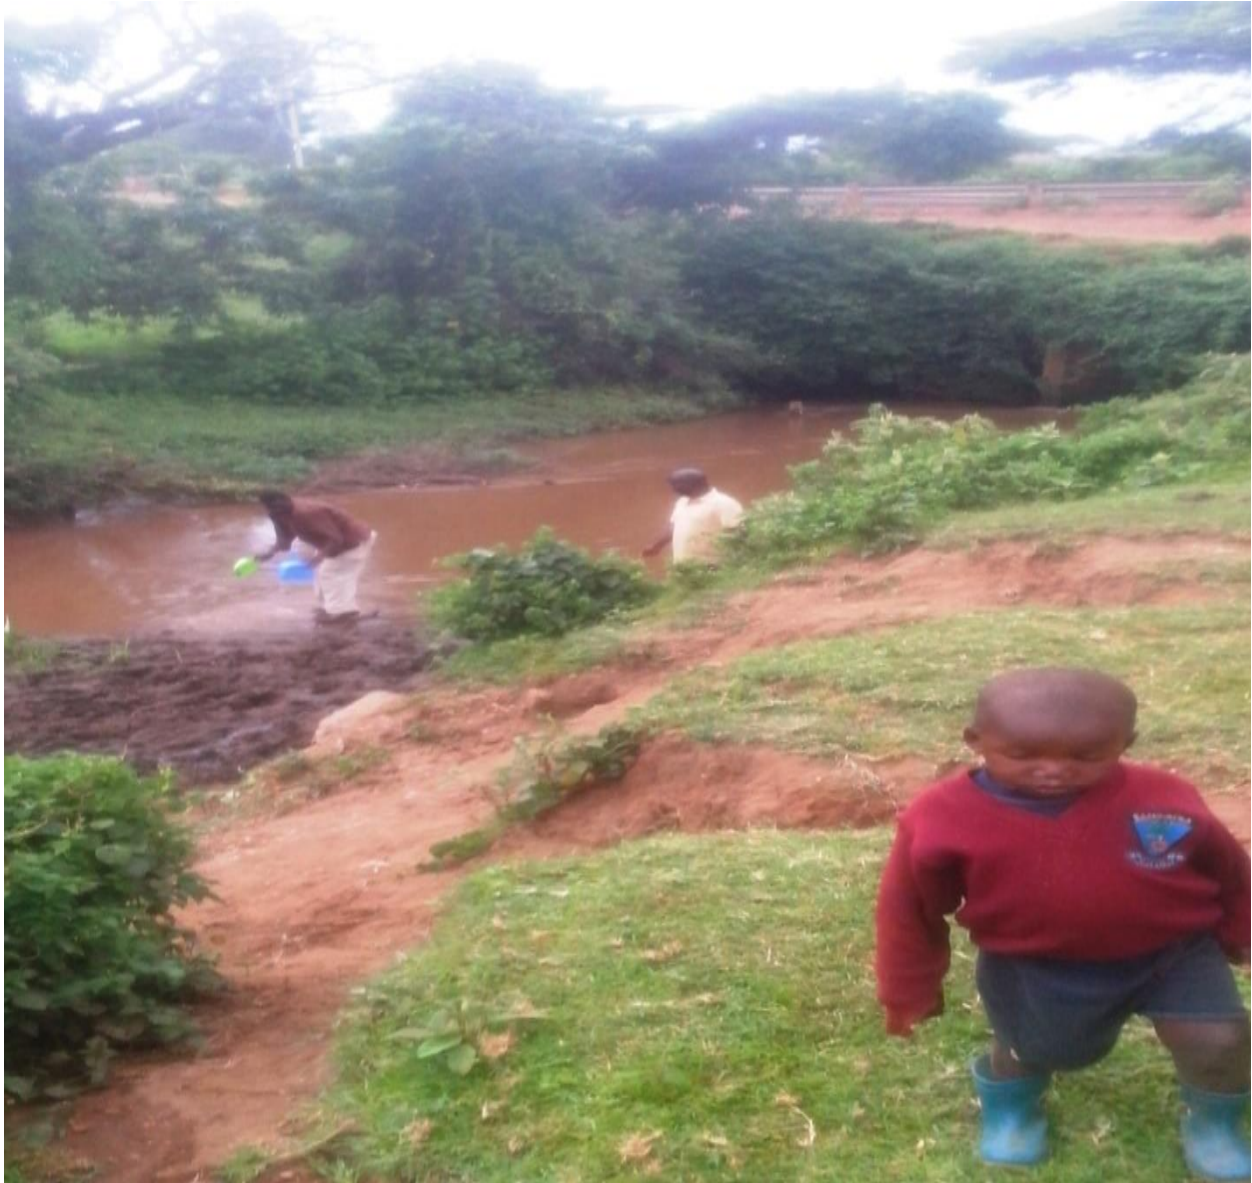
**Appendix 4: Sediment sampling in River Moiben, Cherangany forest Ecosystem**

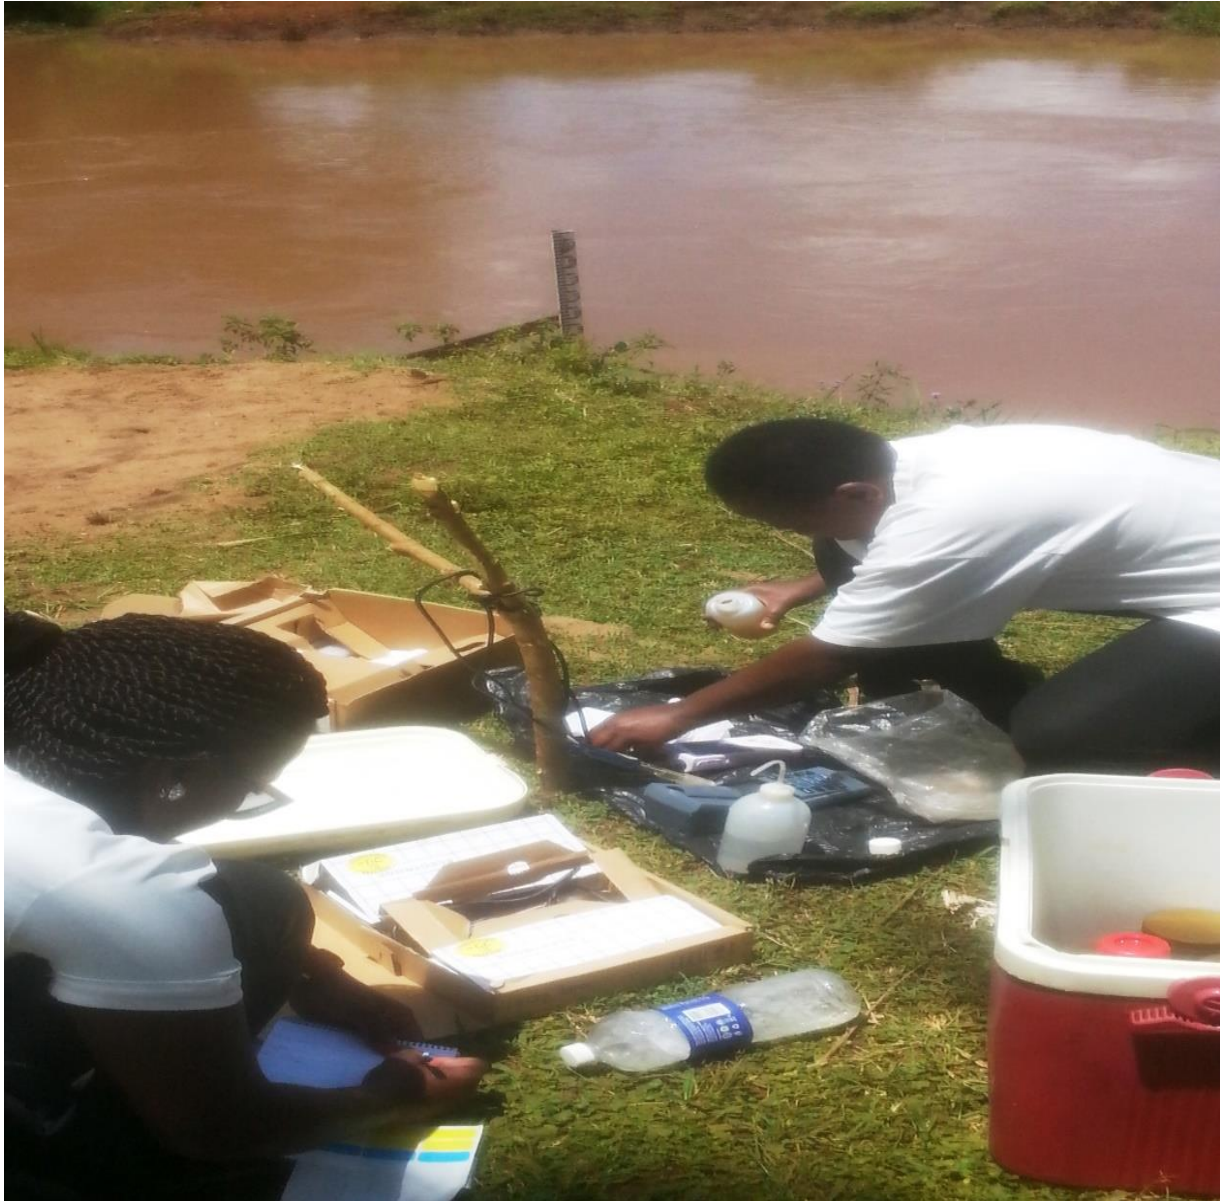
**Appendix 5: On-site Water and Sediment sampling and analysis in River Kiminin in Bungoma County, Mt. Elgon Ecosystem**

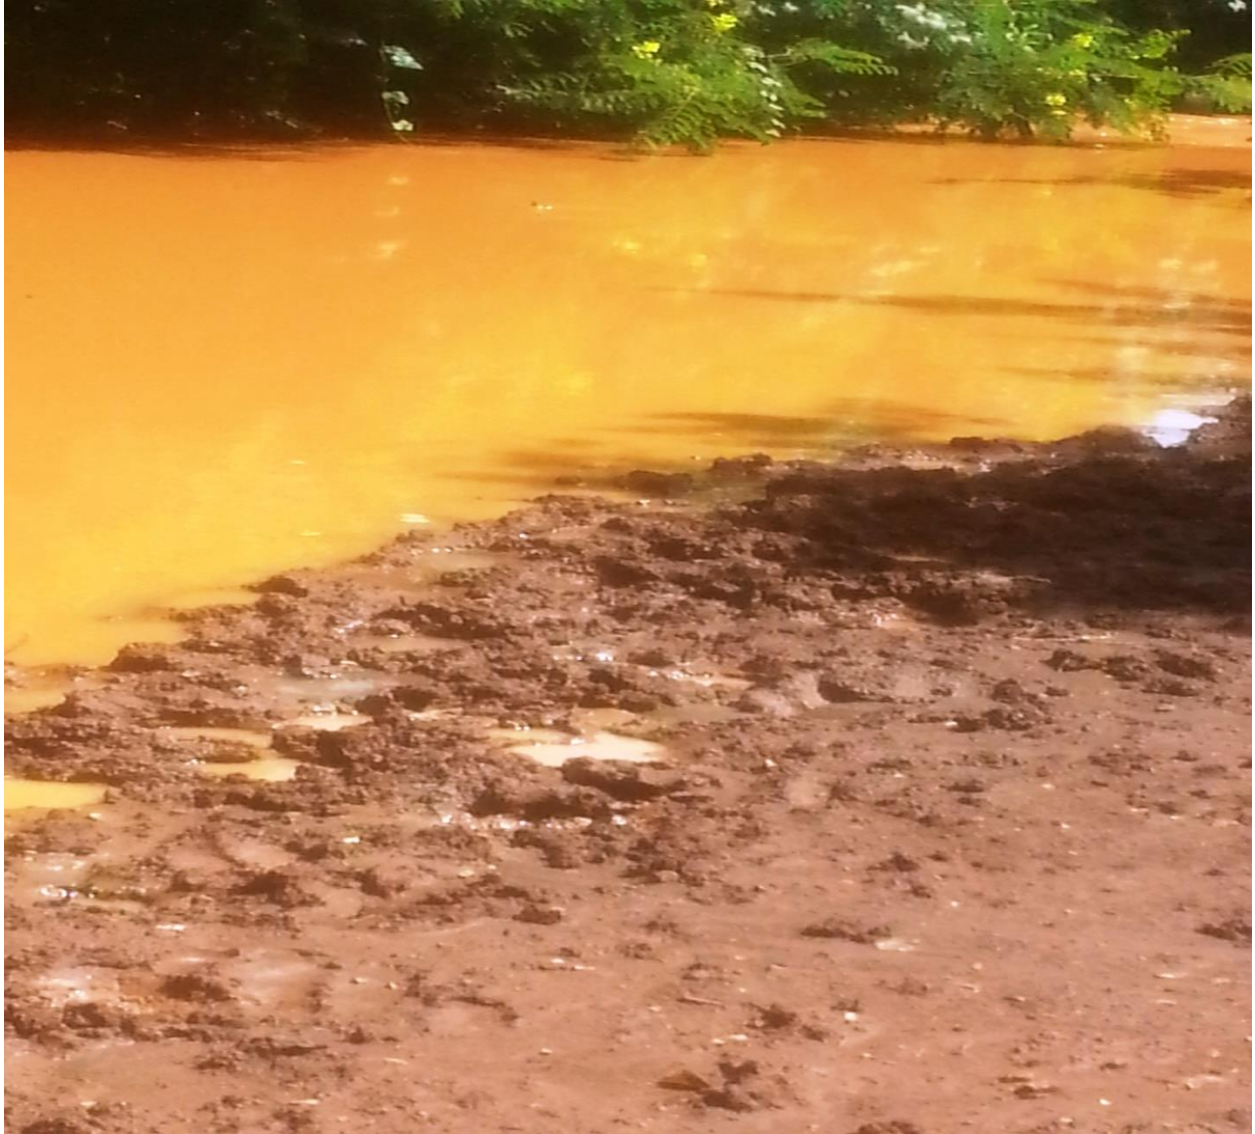
**Appendix 7: River Mubere (Mt. Elgon Forest Ecosystem) (High turbidity or murkiness caused by livestock watering)**
